## Land Drainage in Somerset

This is the season of year when flooding events hit the news all over the country and this seemed an opportune time to look at the Somerset Levels and outline of one of the major works which have taken place in the county. The Huntspill River is a wide artificial water course which acts as a drainage channel as well as a reservoir in the Brue valley.

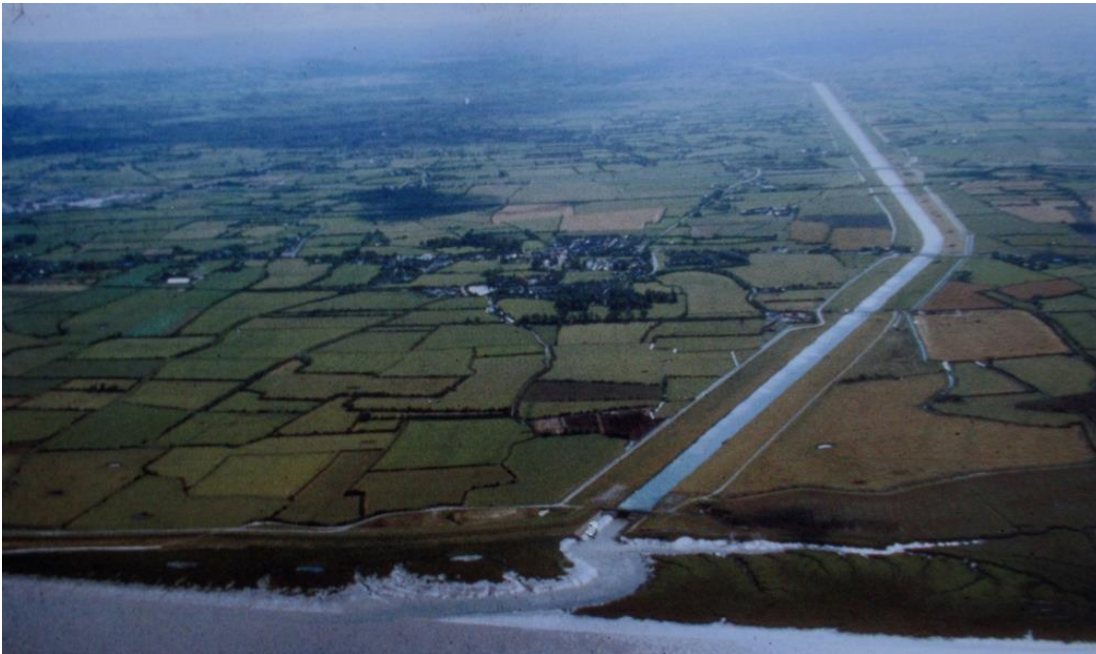
*Huntspill Sluice at the river's western end separates the river from the River Parret. Courtesy SWHT*

The Huntspill River, seen above, was constructed in WW2 to meet the needs of a new ordnance factory at Woolavington near Bridgwater. The factory required 4.5 million gallons of water a day. The idea for a drainage scheme in this area originated in the nineteenth century, but was not taken up due to the local river authorities being unable to agree on responsibility; hence they were unwilling to commit the funding required.

The five mile Huntspill River was another major work: the river was designed to act as a reservoir to supply water to the Royal Ordnance Factory and also as a flood relief channel with sluices at each end and a pumping station for filling the cut in winter. The scheme was accepted 'the only plan being a pencil line across an Ordnance Sheet showing what seemed to be the best line for the new flood channel'<sup>4</sup>. The Huntspill was connected to both the South Drain and the North Drain passing through Cripps's Clyse and the South Drain Diversion.

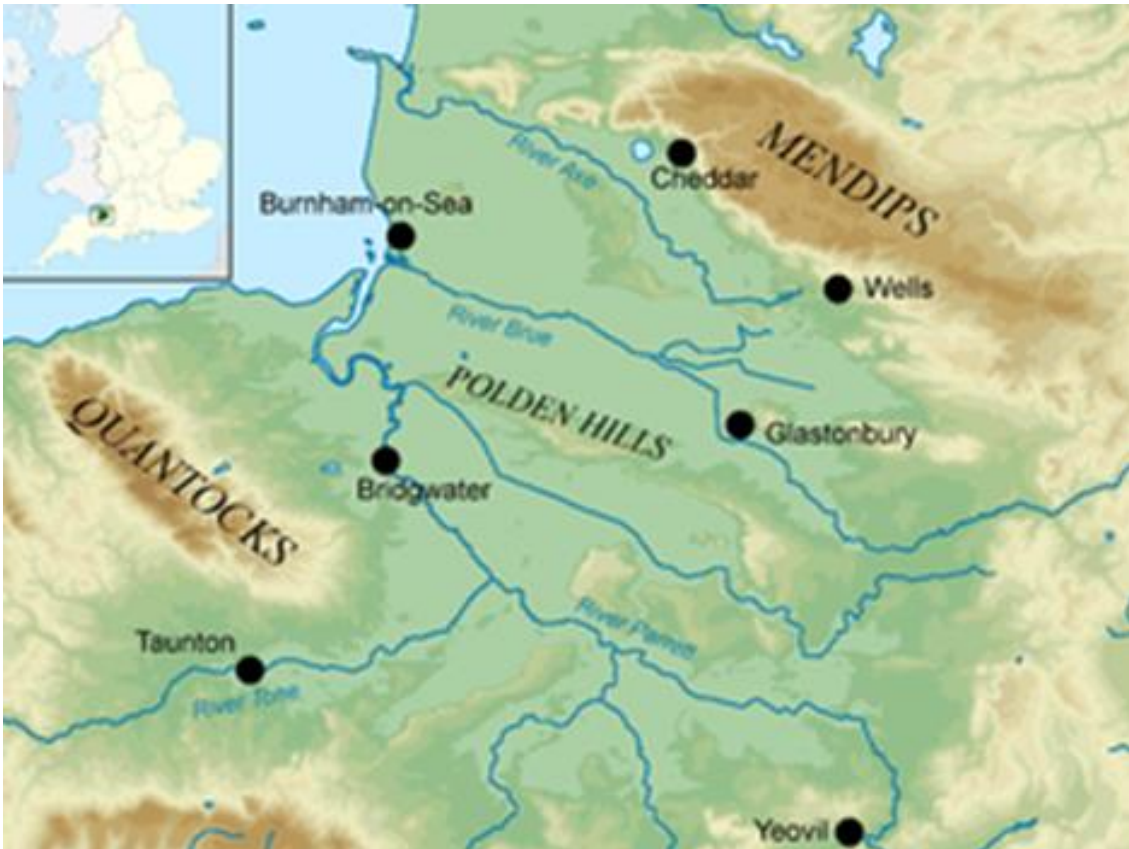
Above: The main rivers in Somerset
