# A Tour of Abandoned Uranium Mines in Navajo Country and Beyond

Compiled by SRIC, October 2013

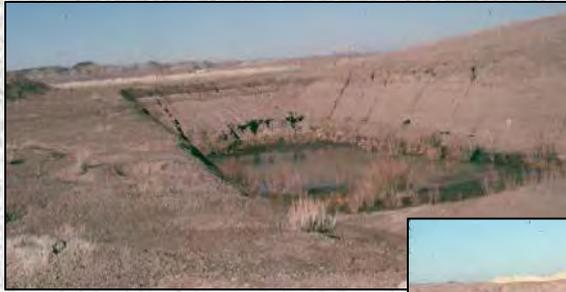
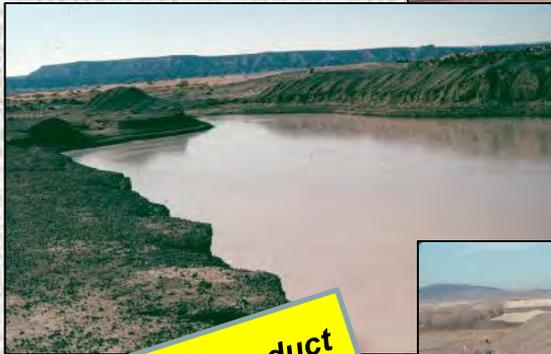
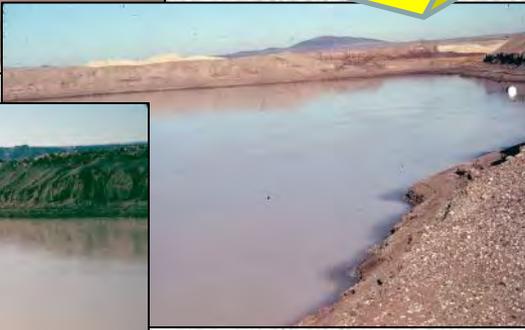
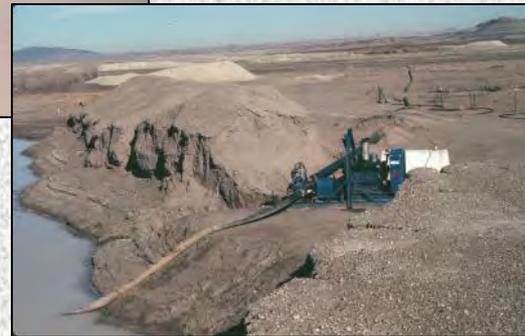
**1982:** SRIC staff took the photos below before these open pit uranium mines were backfilled and closed by NMAML in the 1990s. Most of these pits no longer have standing water. Residents and livestock consumed water from these pits, which was shown to be contaminated by uranium and other radioactive substances.

High levels of uranium & radium found in water in these pits in 1970s

EPNG will conduct site assessments in 2014 under USEPA order of 9/13/13

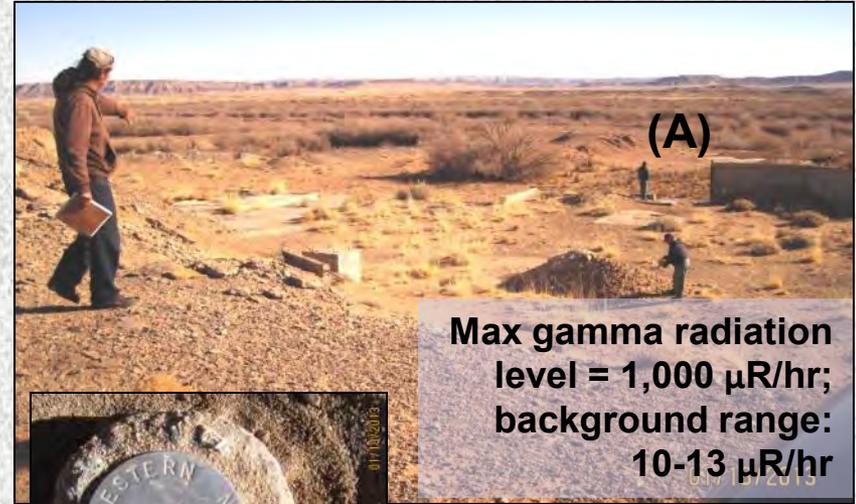
**2013:** (A) Unreclaimed ore transfer station and (B) open pit mine, ~10.5 mi SE Cameron Chapter within 1/4-mile Little Colorado River; (C) Western Nuclear benchmark next to open pit.

Max gamma radiation level = 1,000  $\mu\text{R/hr}$ ; background range: 10-13  $\mu\text{R/hr}$

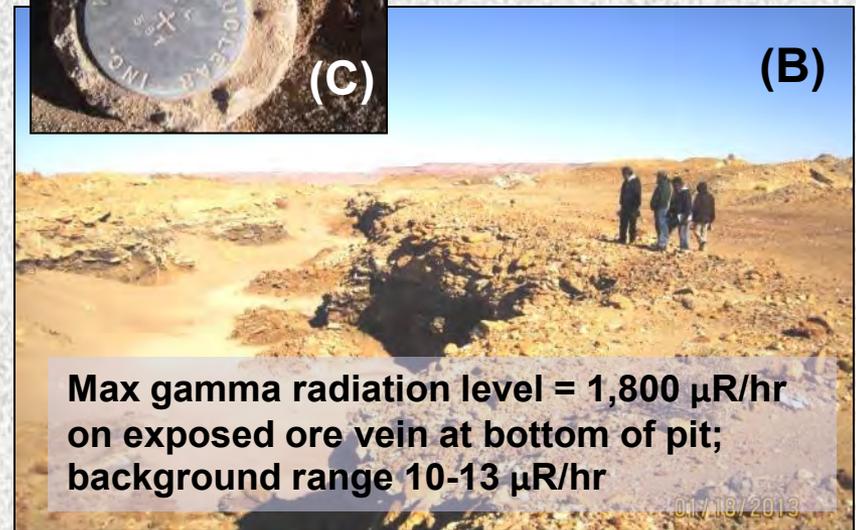
Max gamma radiation level = 1,800  $\mu\text{R/hr}$  on exposed ore vein at bottom of pit; background range 10-13  $\mu\text{R/hr}$

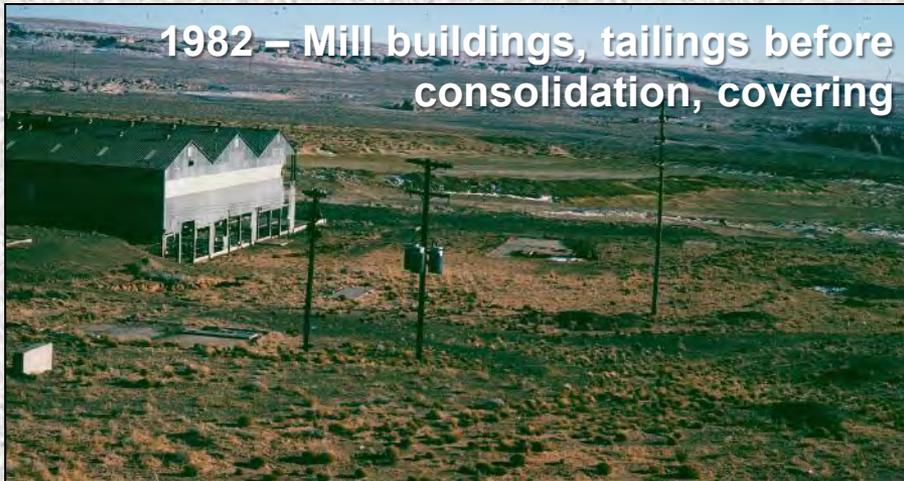
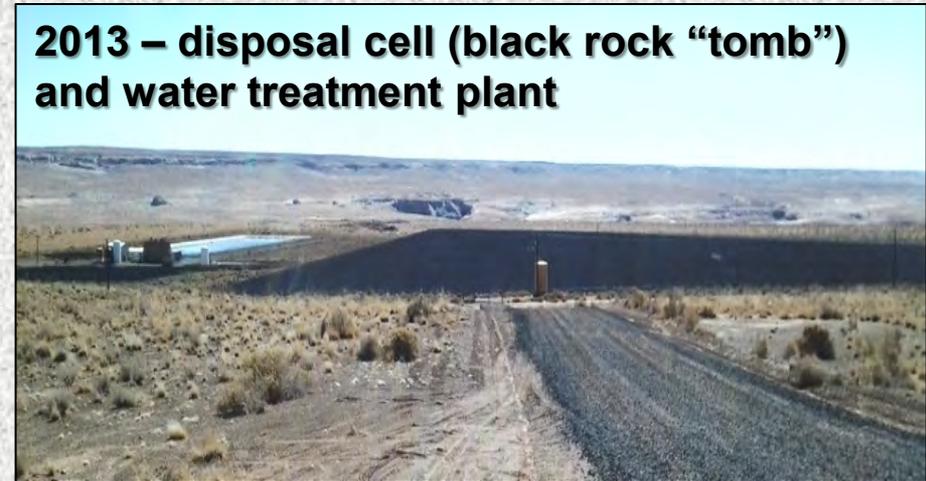
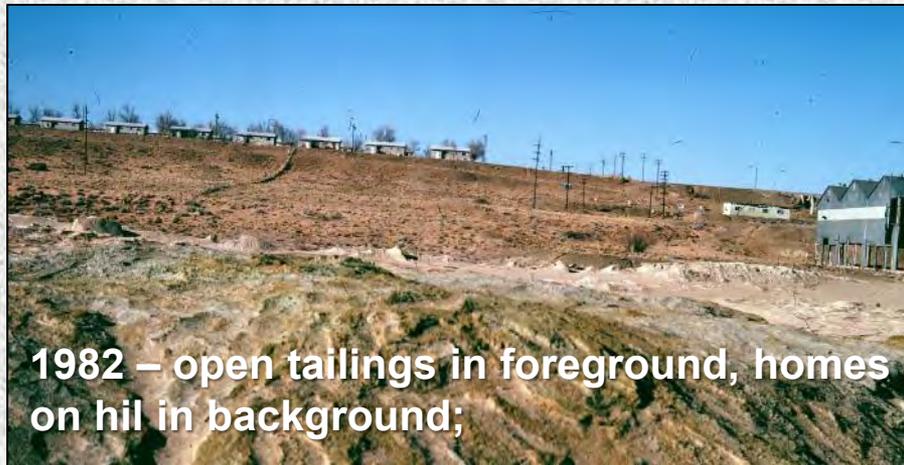
# Then and Now: Rare Metals Uranium Mill Tailings Disposal Cell (aka, Tuba City UMTRA Site)

- Operated 1956-1966, processing Cameron uranium ores
- “Stabilization-in-place”, 1986-1990
- Groundwater contamination, leakage into Moenkopi Wash ongoing after 30 years of treatment
- See, <http://www.lm.doe.gov/tuba/>

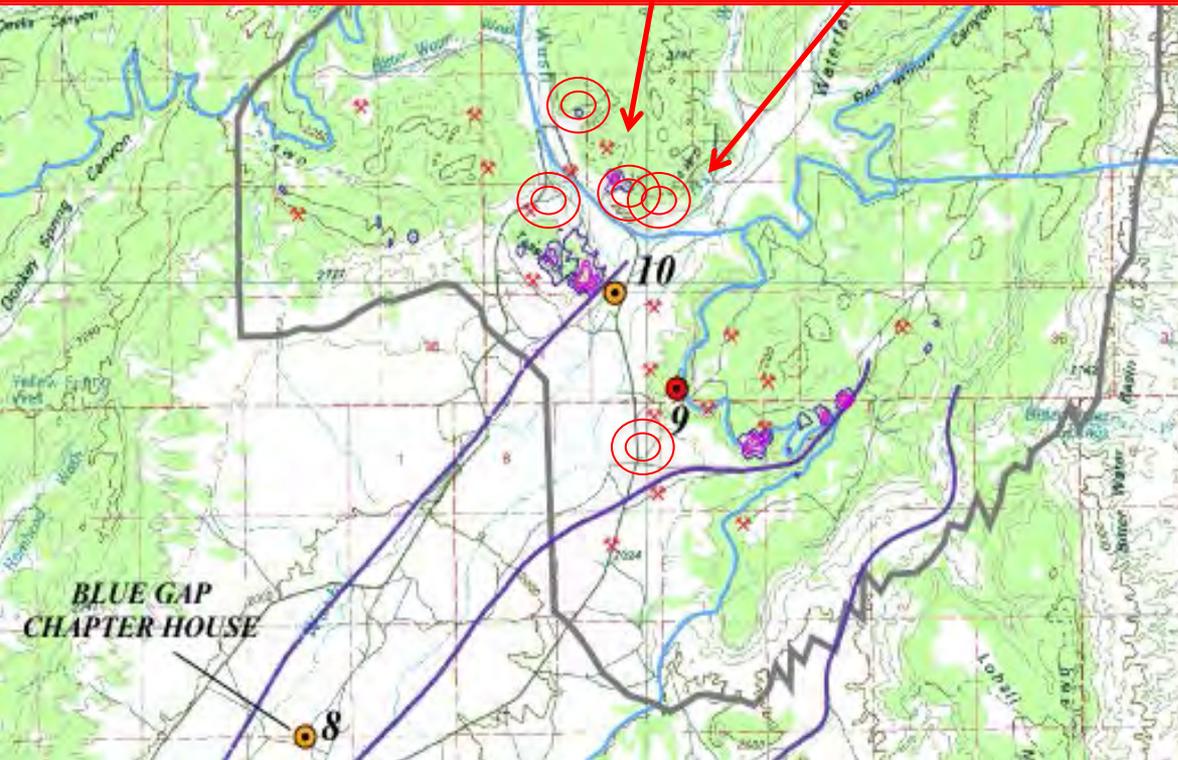
Uranium mine waste dump on slope

~150 ft.

Residences

- 5 residences (20-25 people) within 1 mile of mine dump
- 3<sup>rd</sup> largest mine in terms of uranium ore production in Tachee Mining District
  - 4.2 million tons ore produced, 1957-1968
- NNAML placed dirt cover on waste dump in 1992 to stabilize materials
- NNEPA, USEPA, NNAML site assessments in 1990, 2009, 2011
- SRIC radiation survey 7/9/13:
  - Gamma radiation on waste dump slope 2 to 5 times greater than local background (i.e., 40-100 microRoentgens per hour)
  - Several “hot spots” (gamma rates at least 2x background) found in surrounding community
  - Area has higher background radiation than other places on Navajo Nation

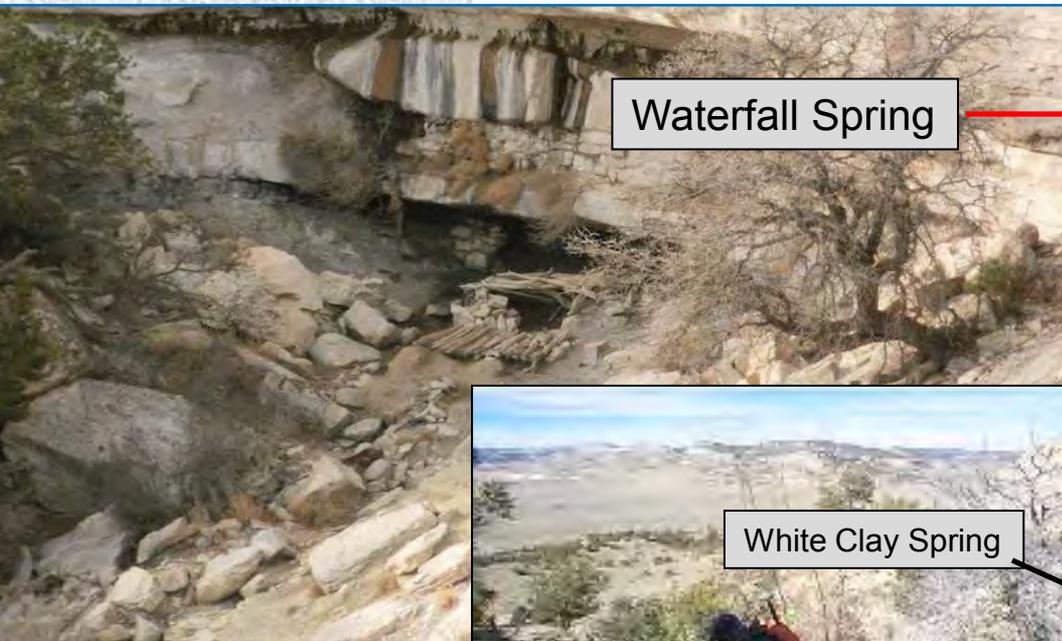
Waterfall Spring

**Waterfall Spring and White Clay Spring had uranium levels exceeding drinking water standards in samples collected in 1998. No testing has been done since then. These springs are still used by local residents.**

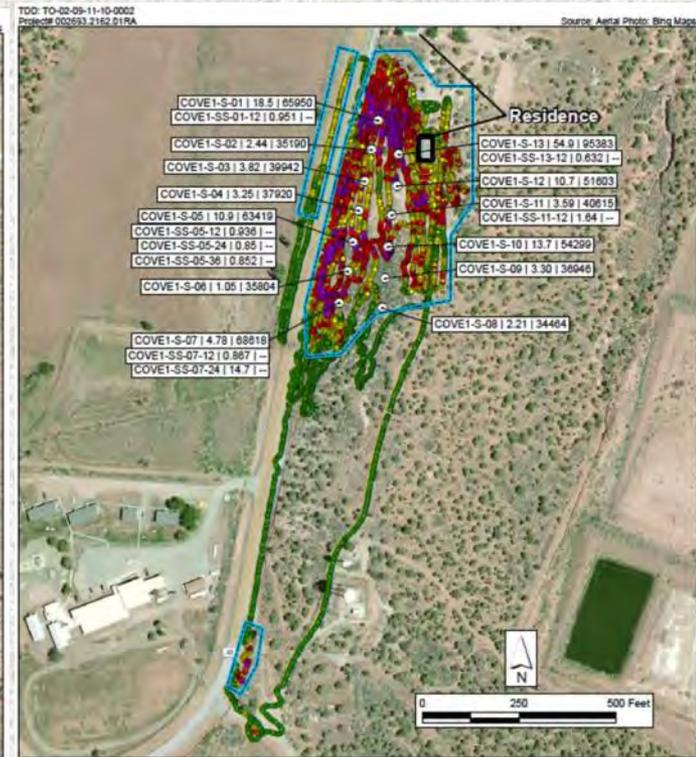
Figure 2  
Transfer Station 1  
Surface Gamma Activity and  
Ra-226 Soil Sampling Locations  
Cove, Apache County, Arizona

Depth	Sample ID	Ra-226 (pCi/g)	One Minute Gamma Activity Count (cpm)
Surface	COVE1-S-01	0.305	65,950
Subsurface	COVE1-S-01-L2	0.951	---

In the maps above, green dots indicate “background,” or natural radiation levels. Yellow, red and purple dots indicate increasing levels of gamma radiation indicative of mining-related contamination.

Two uranium ore transfer stations located in Cove Chapter (map on left) were the sites of removal of radioactive wastes by USEPA and Navajo EPA in 2012. The two sites were contaminated by years of dumping and storing uranium ore removed from mines on nearby mesa slopes. Radiation surveys showed high levels of gamma radiation near homes (middle map) and a school (right map). *Maps courtesy USEPA.*

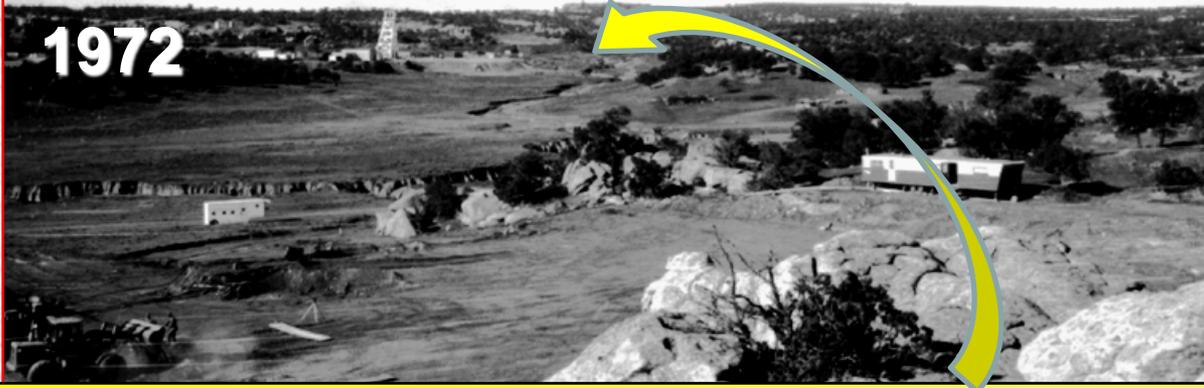
1972

Mine water discharges to Pipeline Arroyo, 1969-1983: More radioactivity released to Puerco River system by mine dewatering than 1979 tailings spill.

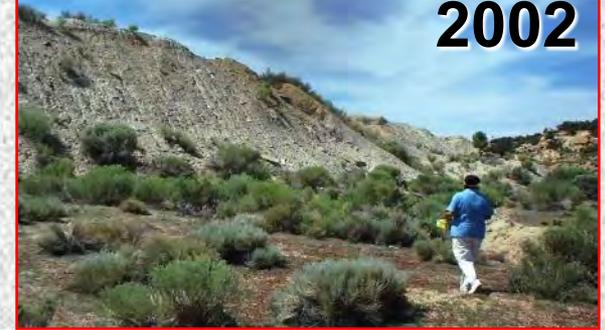
CRUMP radiation monitoring, 2002

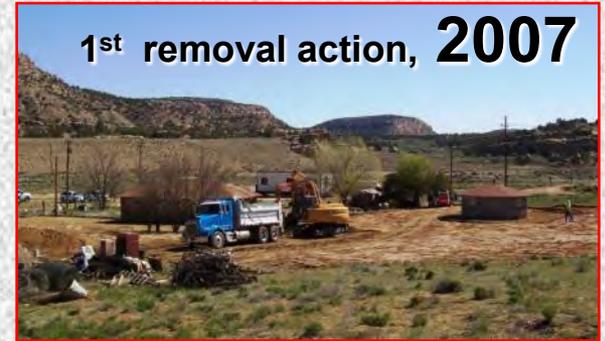
1<sup>st</sup> removal action, 2007

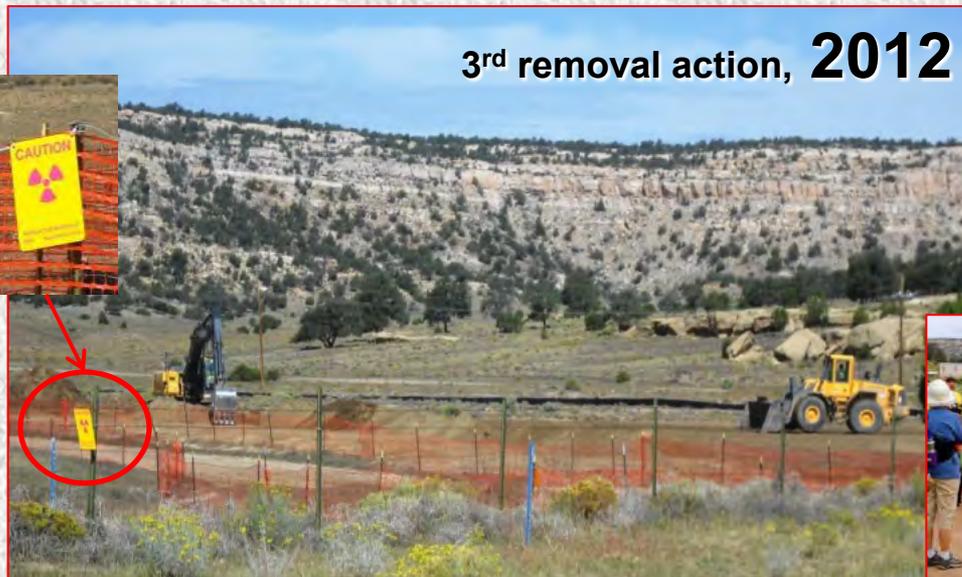
3<sup>rd</sup> removal action, 2012

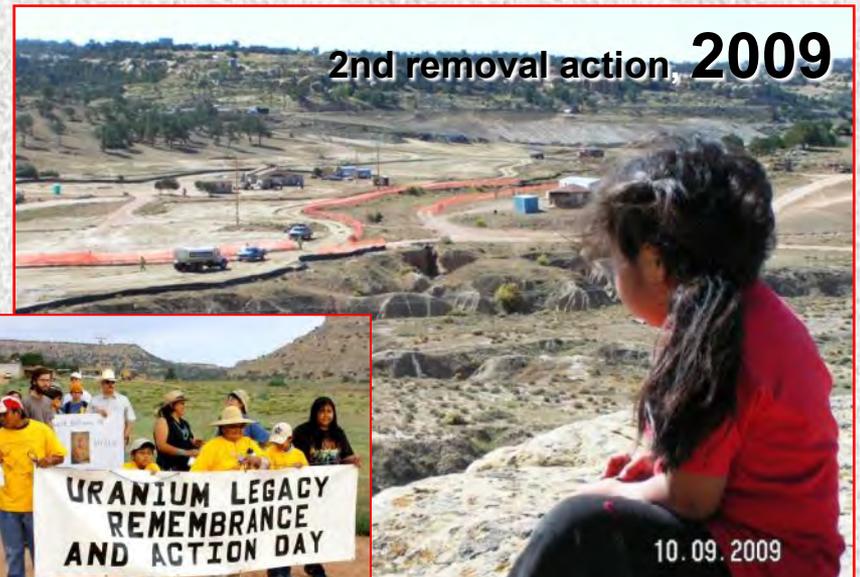
2<sup>nd</sup> removal action, 2009

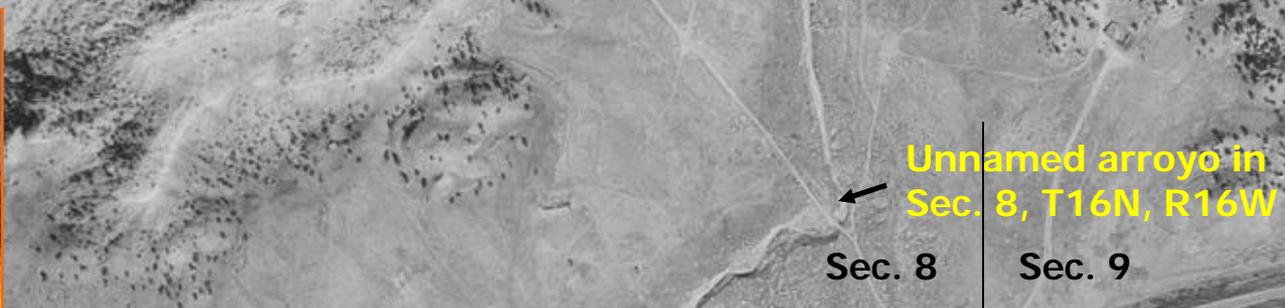
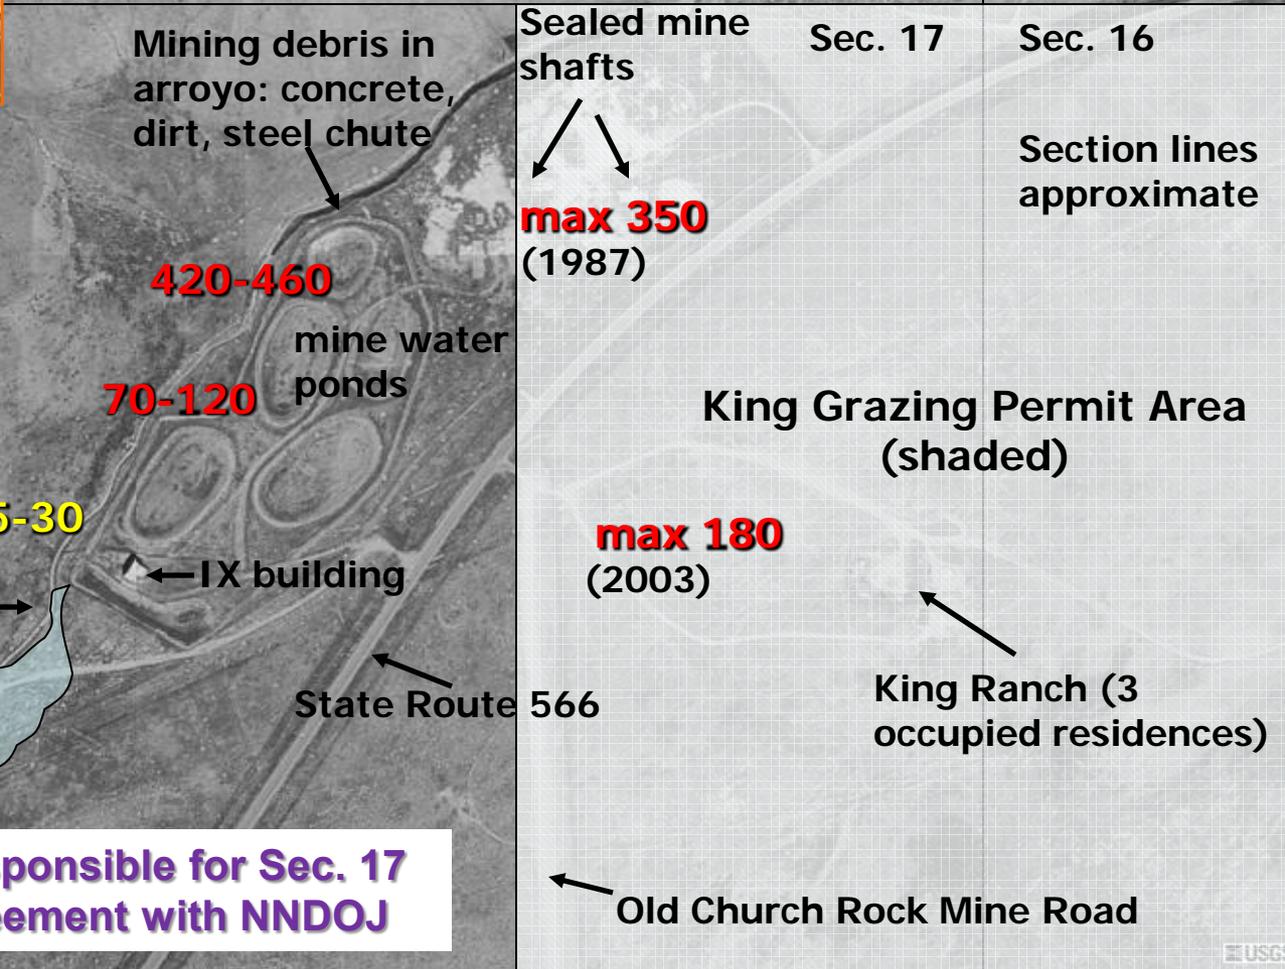
(Gamma radiation rates in micro Roentgens per hour [ $\mu\text{R/hr}$ ]; background rate, 11-13  $\mu\text{R/hr}$ )

Approximate shape of mud delta at mouth of arroyo after flood event

**\*2013 Status: HRI/URI responsible for Sec. 17 cleanup under 2012 agreement with NNDOJ**

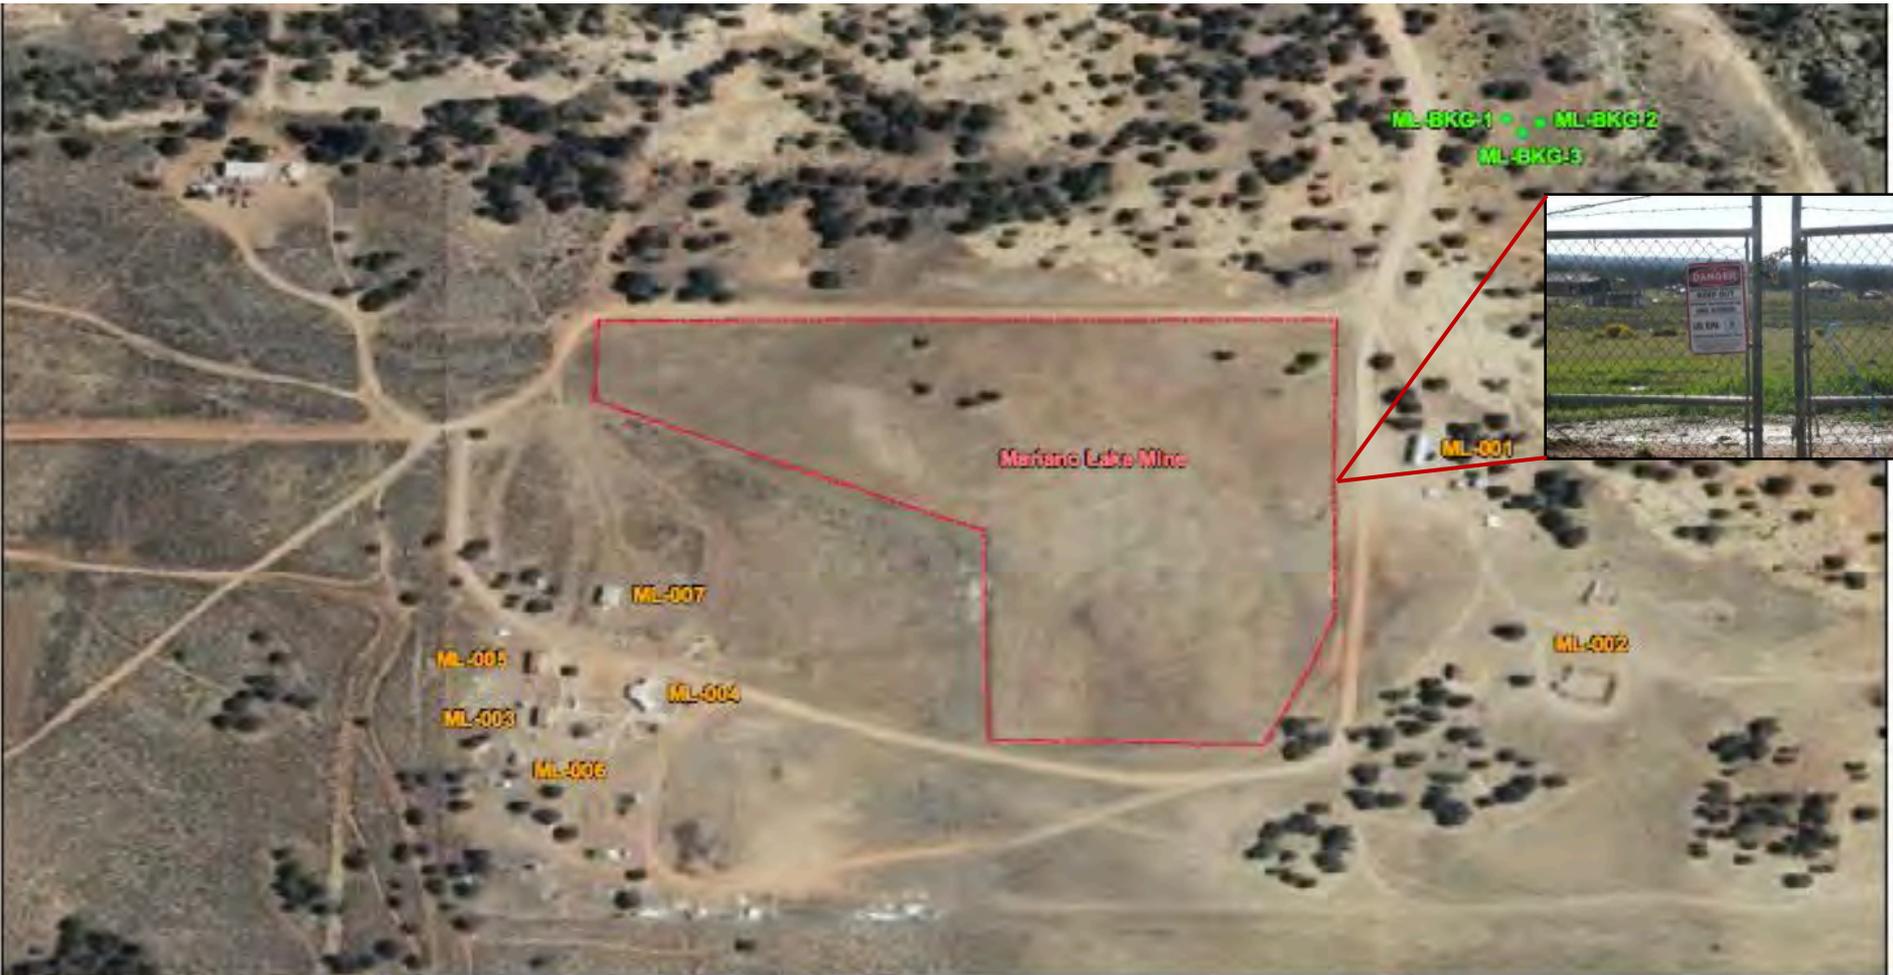
Figure 1  
**Background and Homesite  
Location Map**  
Navajo Radiation Removal  
Mariano Lake  
Navajo Nation Reservation

# Locations of home sites next to Mariano Lake Mine; radiation levels surveyed, 2009-10

Map from Mariano Lake Navajo AUM Site Assessment Summary (fig. 1), prepared by Ecology and Environment, Inc., for USEPA Region 9, Jan. 5, 2010.

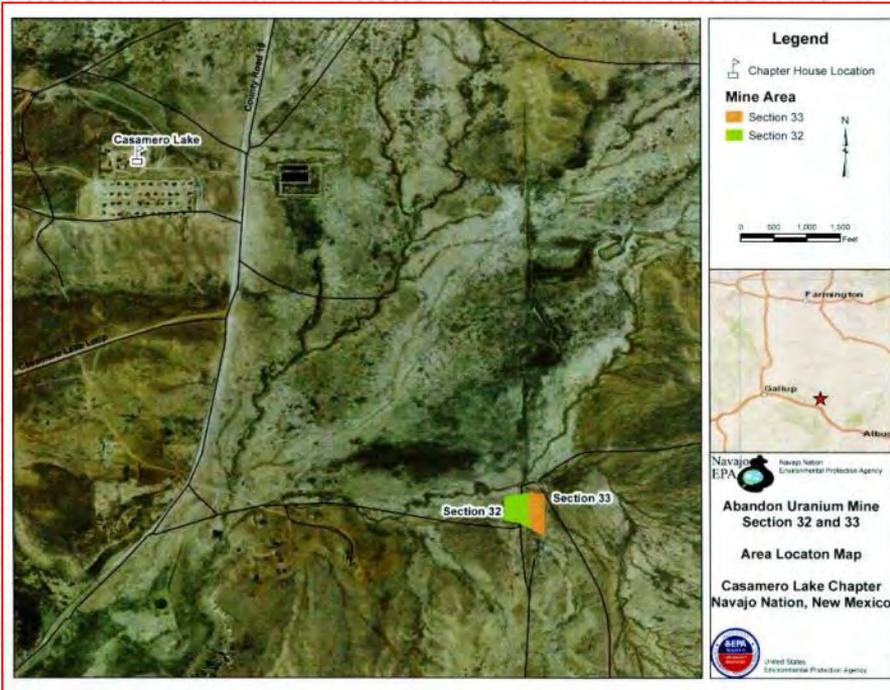
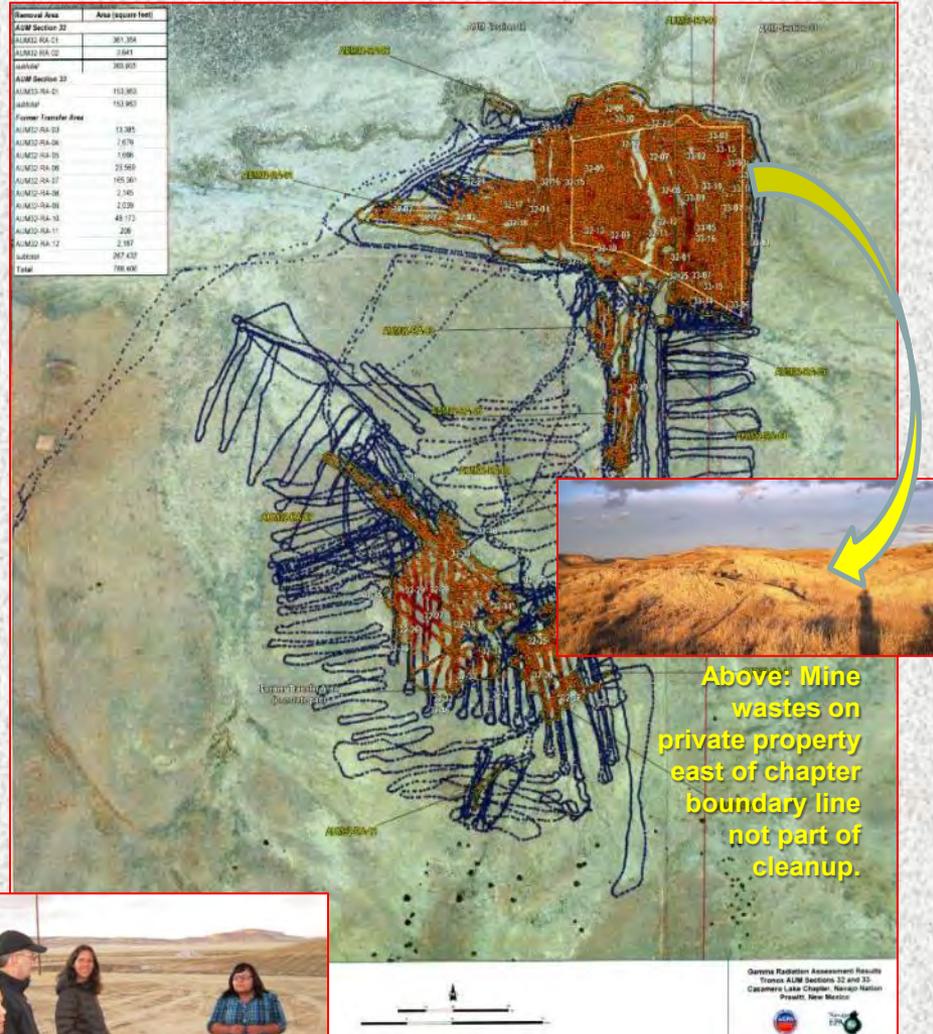
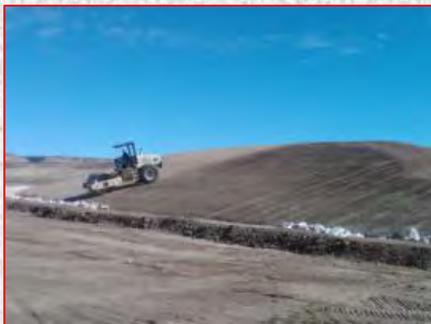
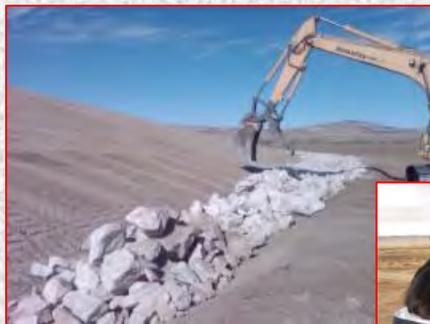
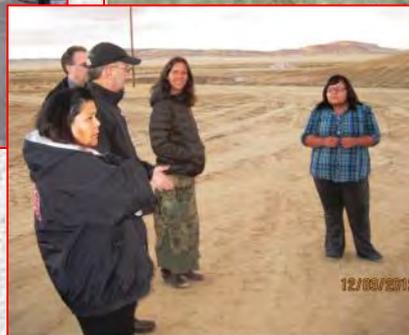
# Section 32-33 Mine Sites, Casamero Lake Chapter

USEPA consolidated uranium mine wastes and covered them with clean dirt and riprap in “interim action” in Fall 2012.

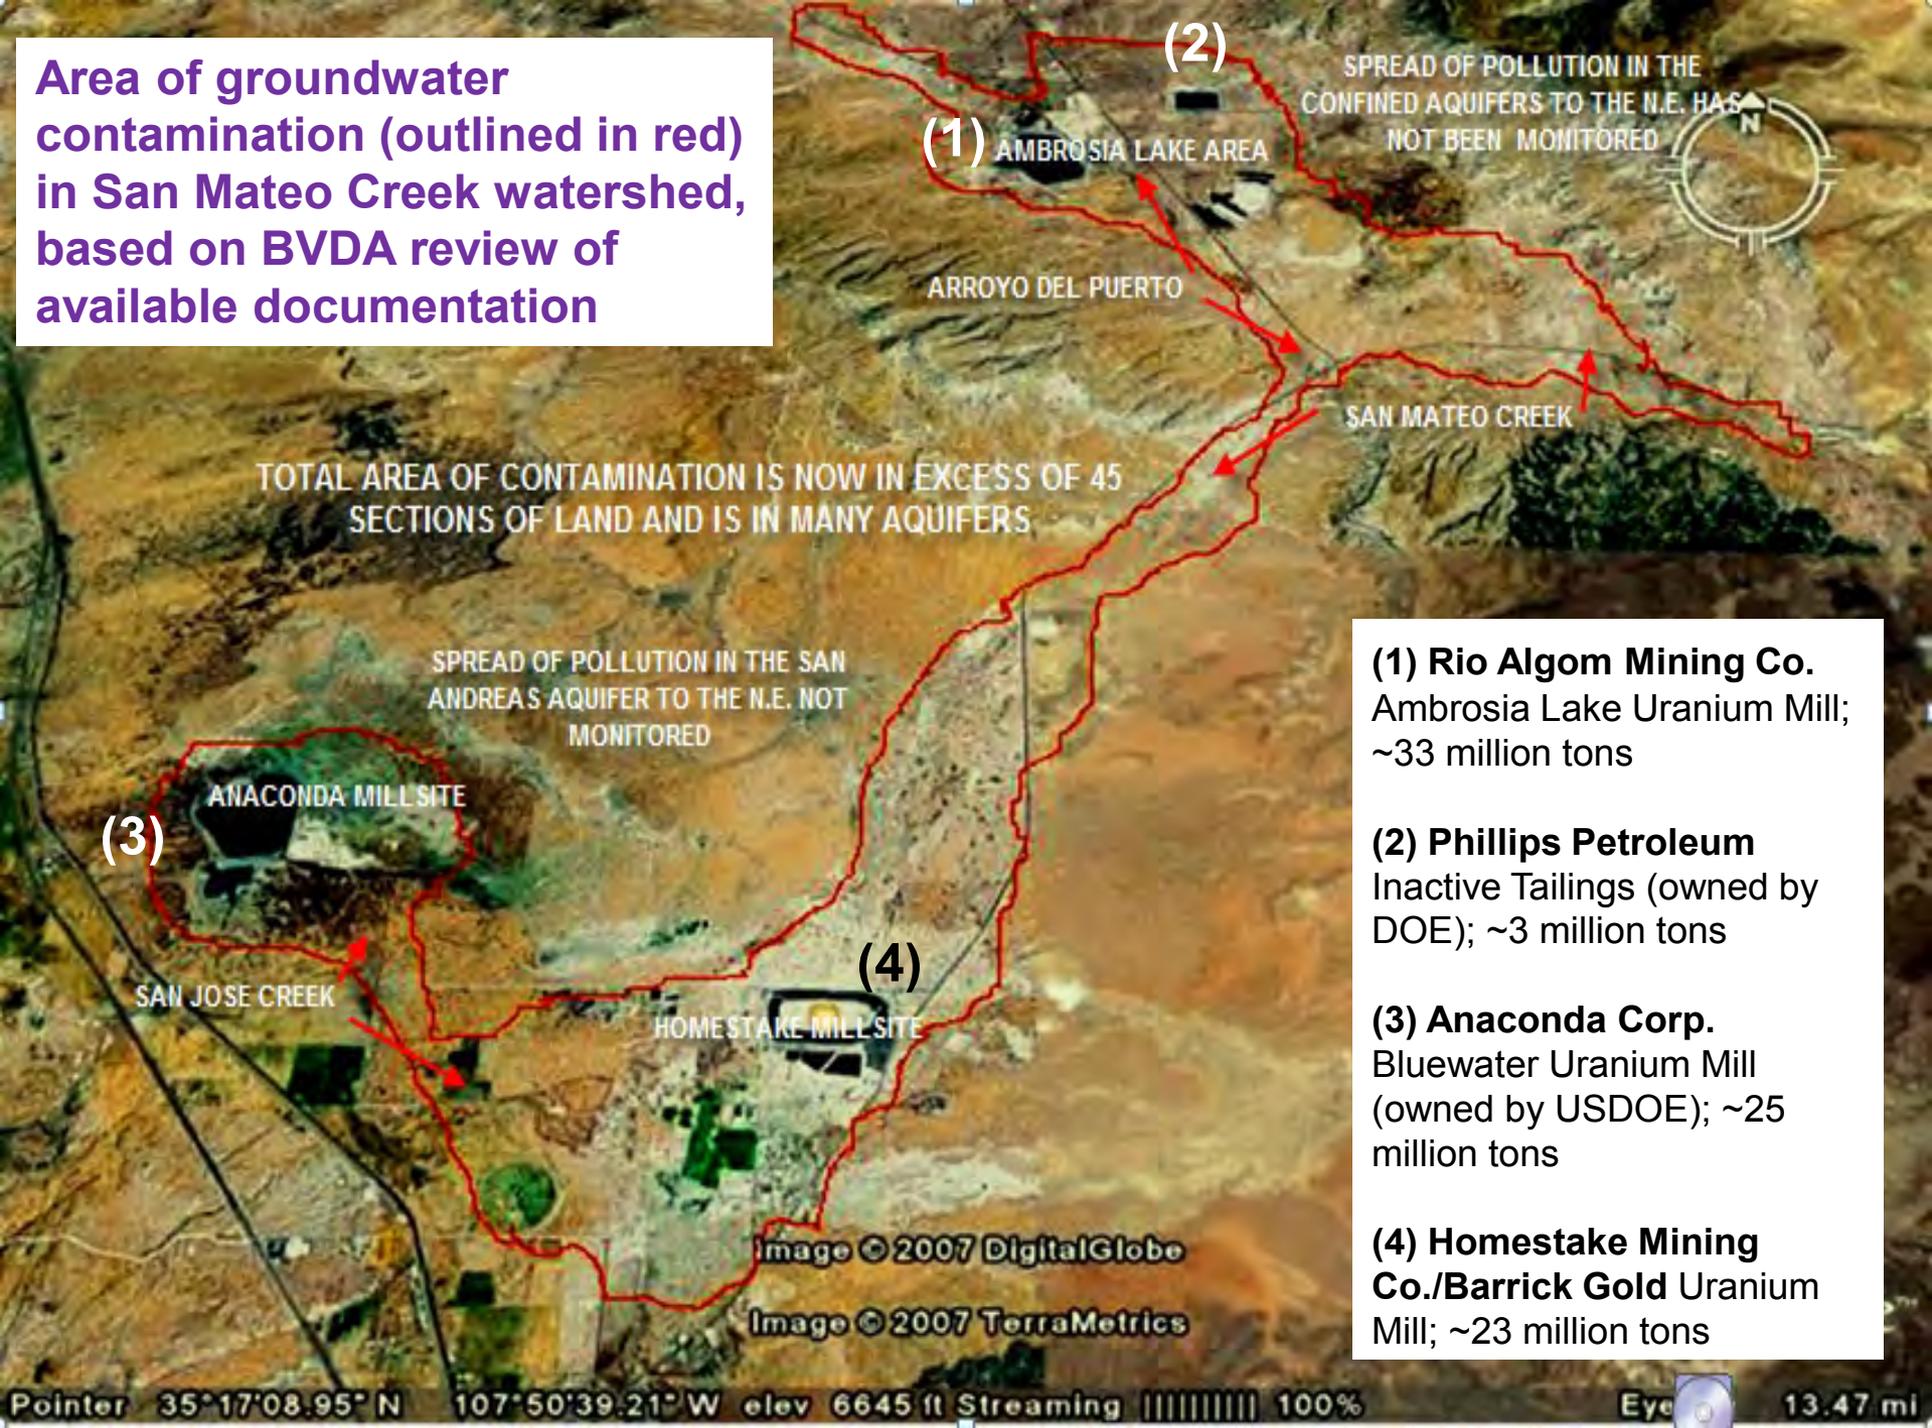
Area of groundwater contamination (outlined in red) in San Mateo Creek watershed, based on BVDA review of available documentation

SPREAD OF POLLUTION IN THE CONFINED AQUIFERS TO THE N.E. HAS NOT BEEN MONITORED

TOTAL AREA OF CONTAMINATION IS NOW IN EXCESS OF 45 SECTIONS OF LAND AND IS IN MANY AQUIFERS

SPREAD OF POLLUTION IN THE SAN ANDREAS AQUIFER TO THE N.E. NOT MONITORED

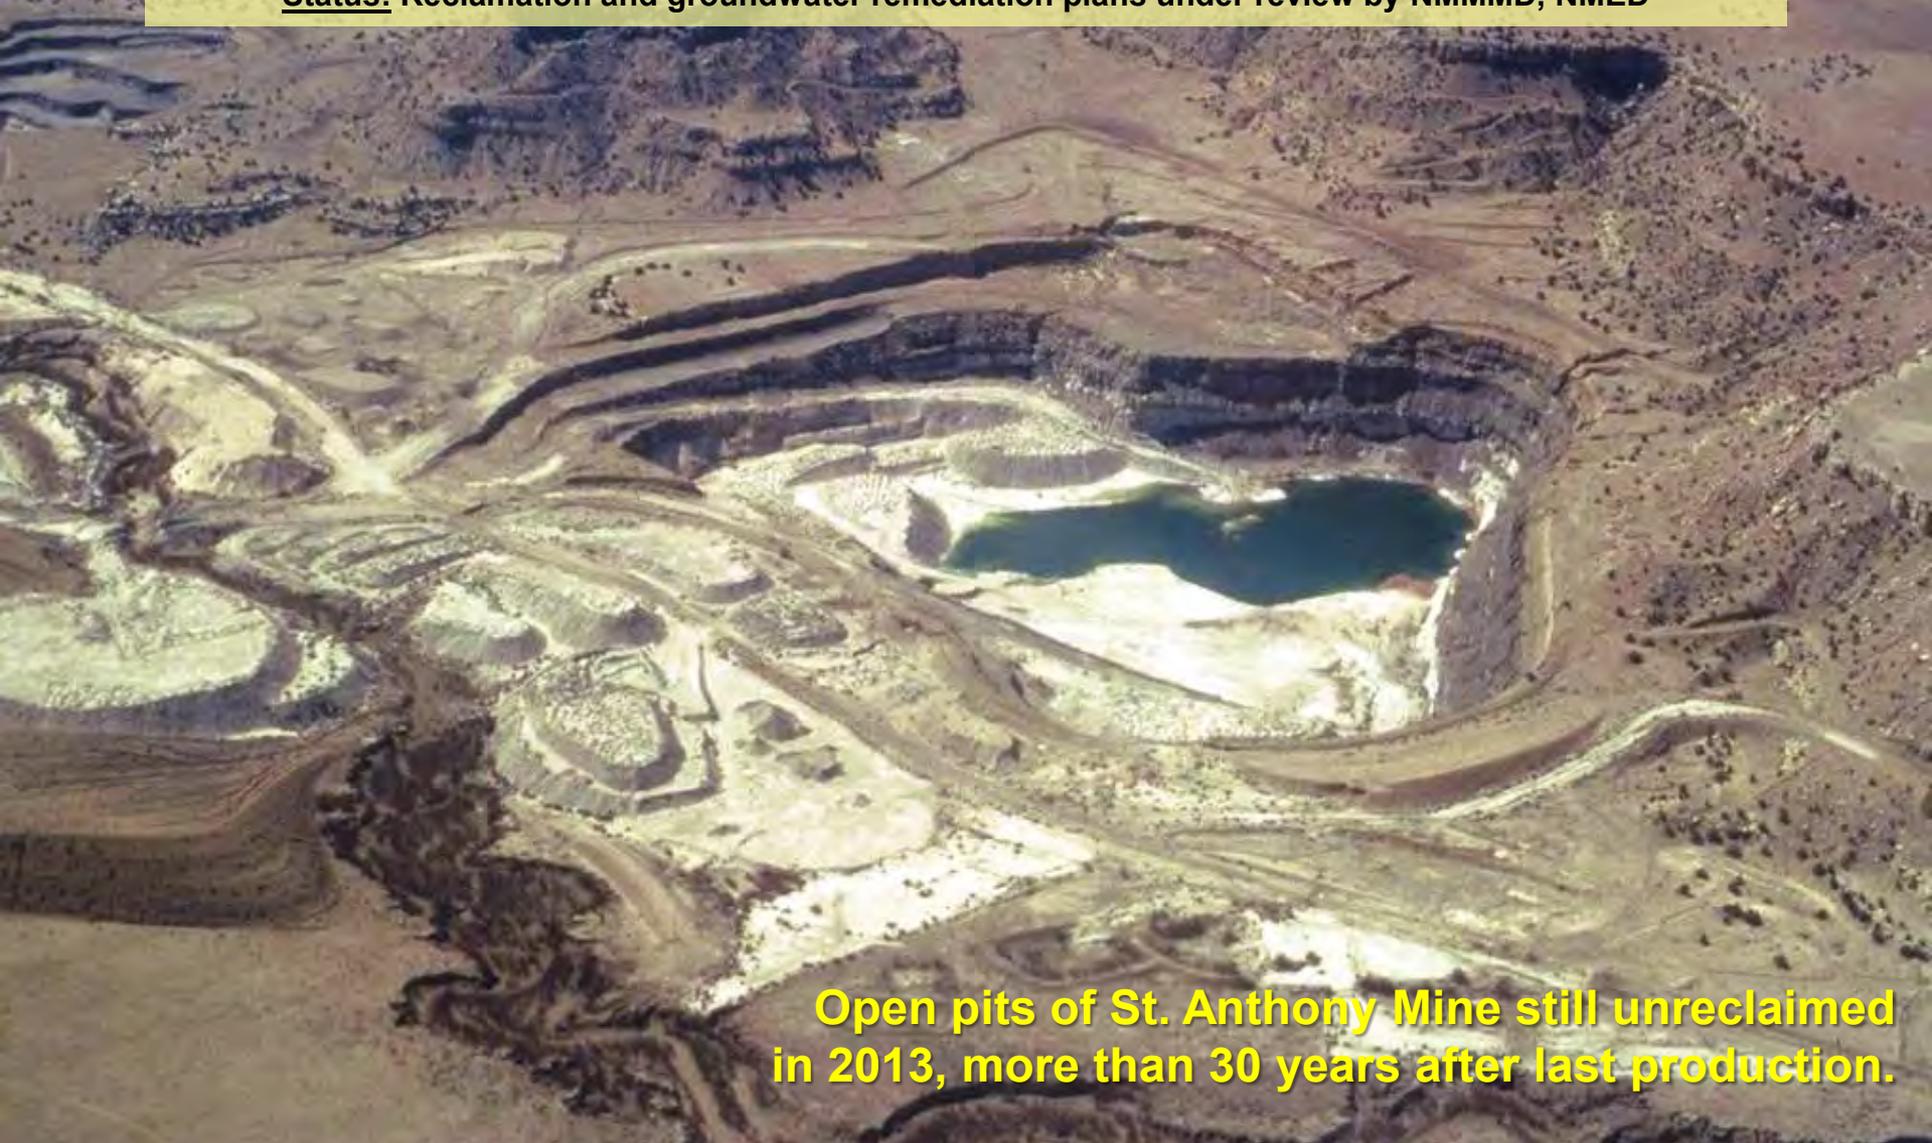
**Open pits of St. Anthony Mine still unreclaimed in 2013, more than 30 years after last production.**

Status: Reclamation and groundwater remediation plans under review by NMMMD, NMED
