MAIDSTONE MODEL ENGINEERING SOCIETY

NEWSLETTER - Winter 1985

INSPECTING LOCOMOTIVE TYPE BOILERS

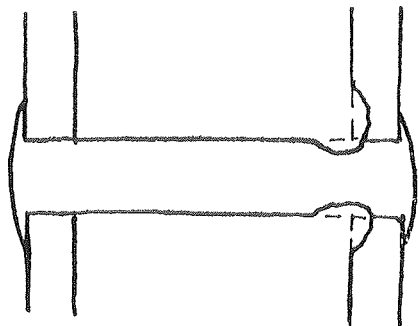
FIG. 2. CORROSION IN CHANNEL FORM AT JUNCTION OF FIREBOX AND FOUNDATION RING

The plates will be examined for pitting, blotching and general wastage. Corrosion in channel form will be searched for at the junction between plates and foundation ring (Fig. 2).

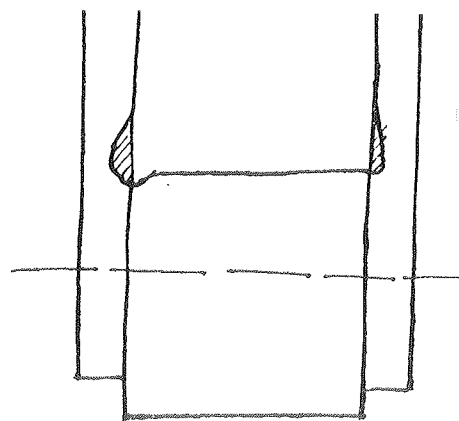
FIG. 1. "NECKING" OF FIREBOX STAY & PLATE WASTAGE IN ANNULAR FORM

The colour of the plate and stay is significant; a fine red or black line often indicates a broken stay. If the junction is broadly discoloured judicious chipping will often reveal severe corrosion in necked form, so reducing the stay diameter that renewal is necessary. If the adjacent plate is wasted in annular form the threads may be insufficient to support the plate, although if the stay head is sound this provides some support (Fig. 1). Stay and adjacent plate defects will generally be more severe in upper stay rows due to differential expansion between the firebox and casing plates.

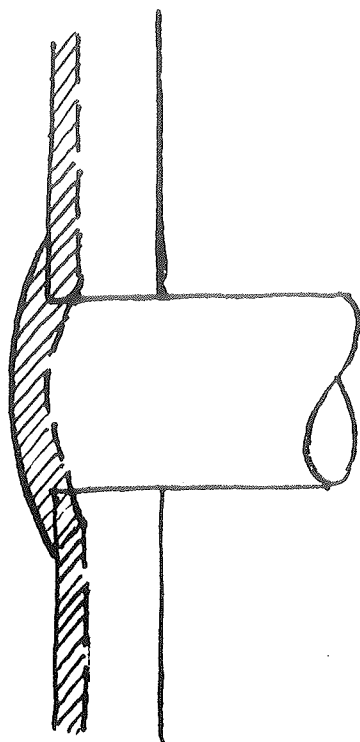
FIG. 3. SMOOTH WASTING. THE HATCHED PORTION HAS WASTED OR BURNED AWAY NOTE STAY HEAD REDUCTION

Examination of the firebox plates on the fireside will be the next step because it is important to relate defects noted internally with those externally, particularly on the exact opposite side of the plate. Smooth wasting of the plates and stay heads is probably the most common defect found on the fireside, particularly so at firebar level in some solid fuel fired boilers (Fig. 3). If conditions warrant, the plates will be drill tested to establish thicknesses beyond doubt.

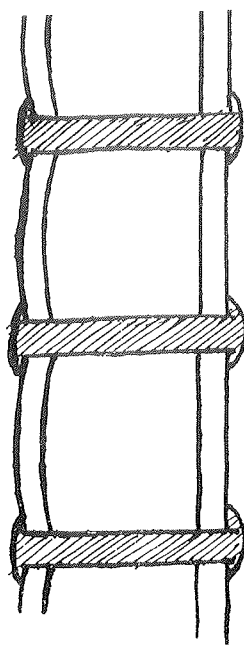
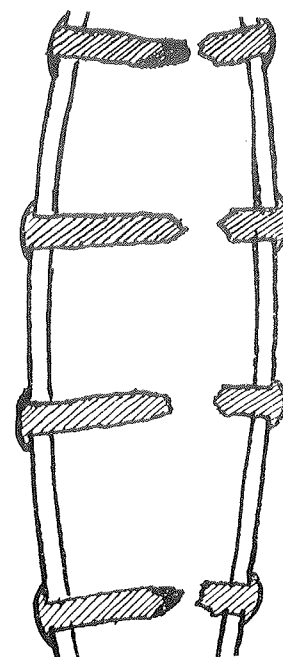
FIG. 4. DISTORTION IN "QUILTED" AND "CONTOUR" FORM.

If distortion is in broad "contour" form, sounding of stays or sample removal would show these to be broken (Fig. 4).
